**Beaver Dam - White River, Arkansas**

**U.S. Army Corps  
of Engineers**  
Little Rock District

# **Beaver Dam Secant Pile Wall Completion Report**

**OCTOBER 1995**

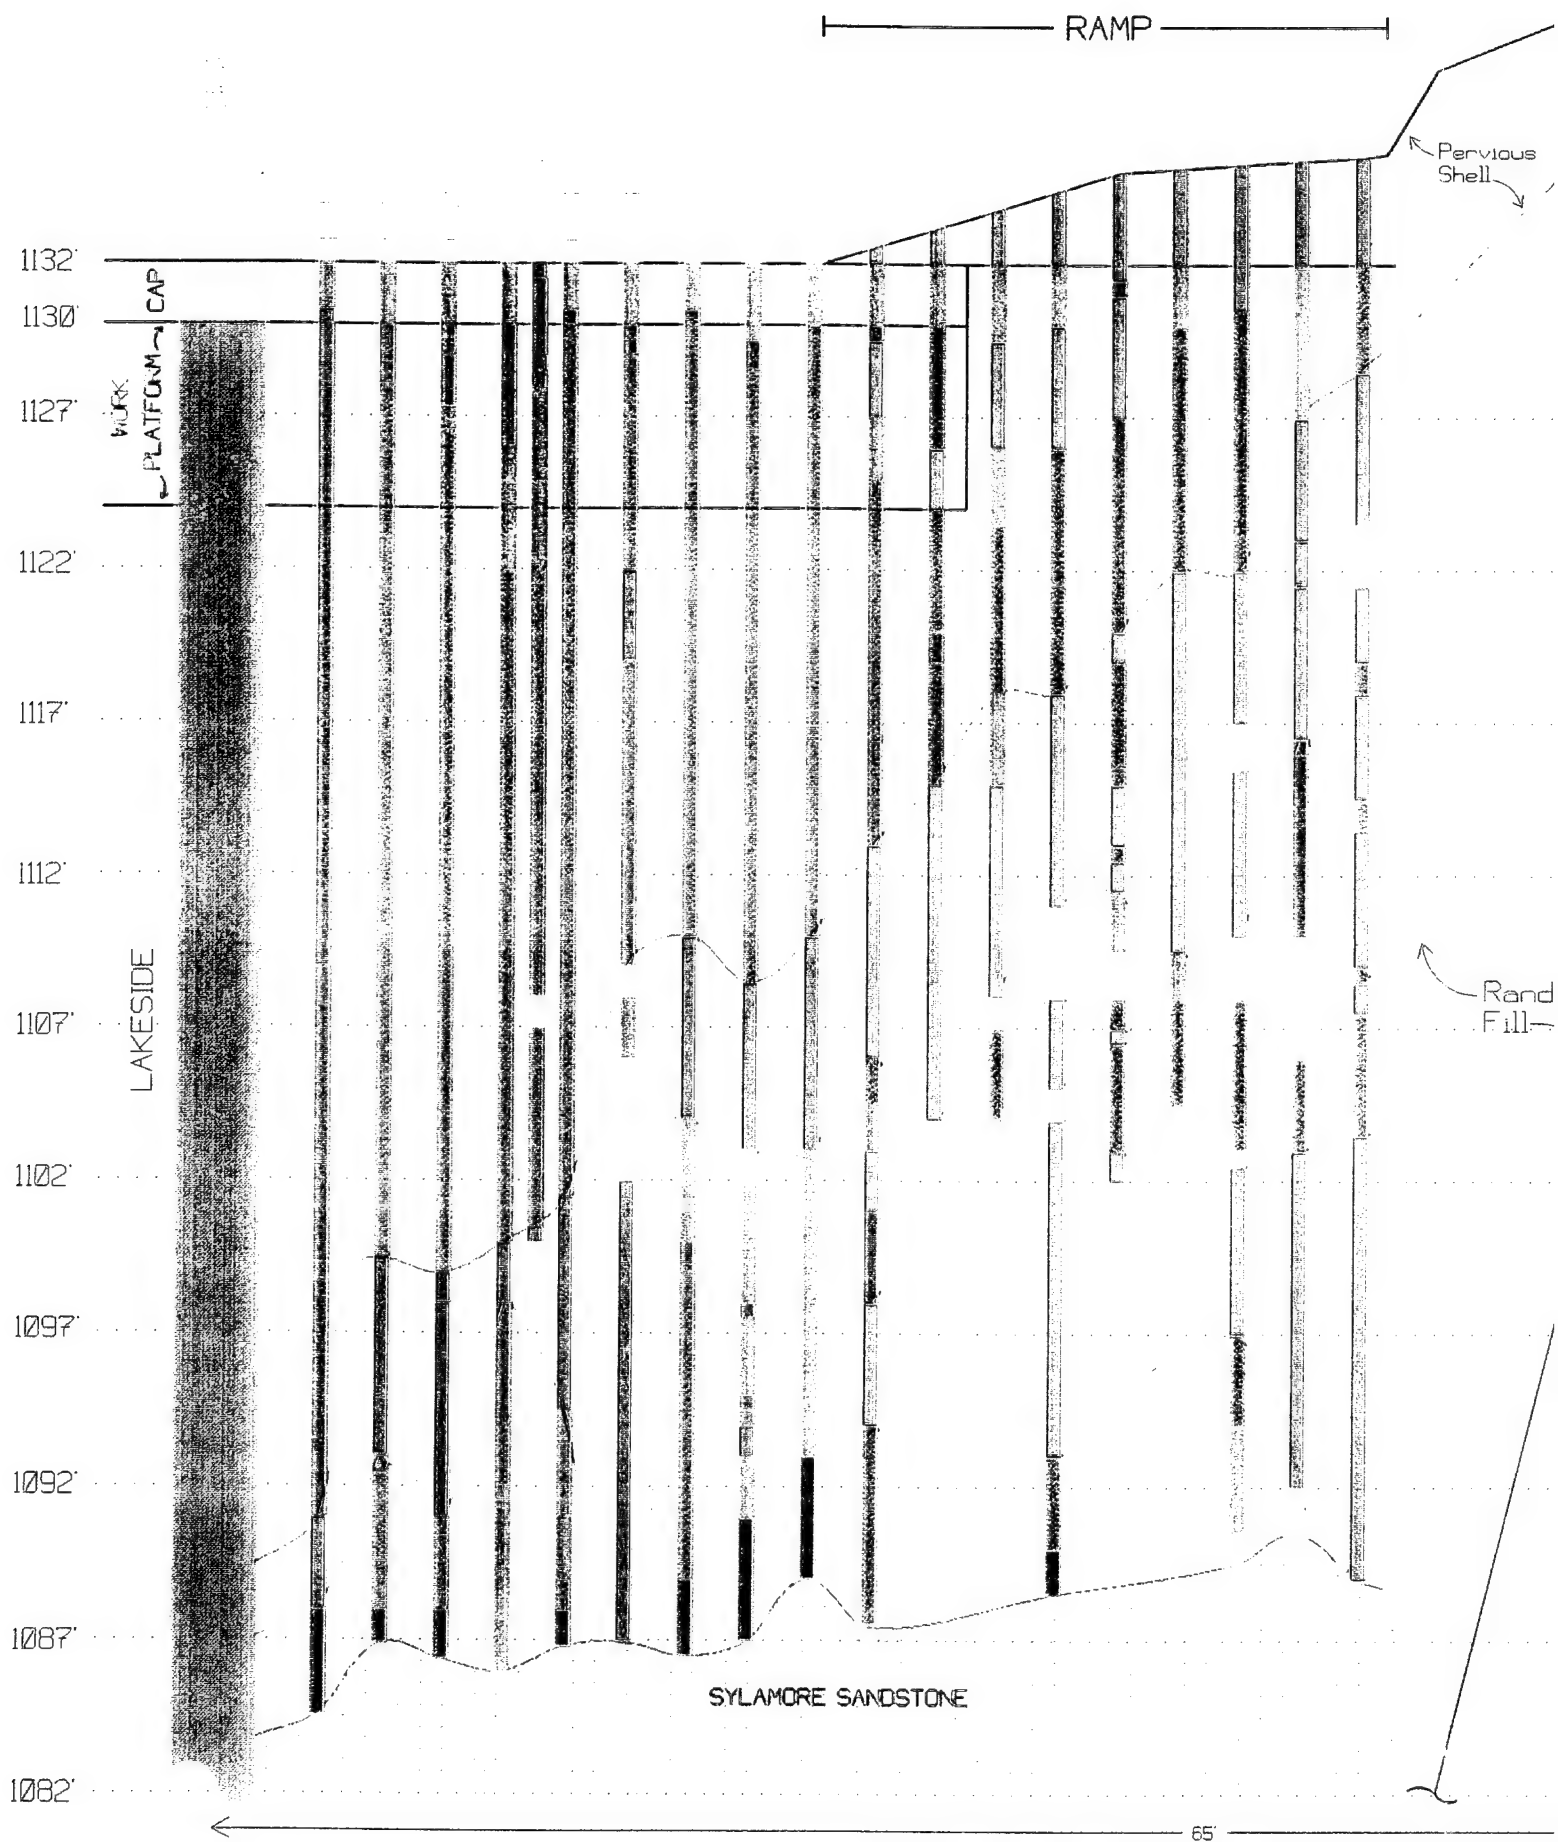
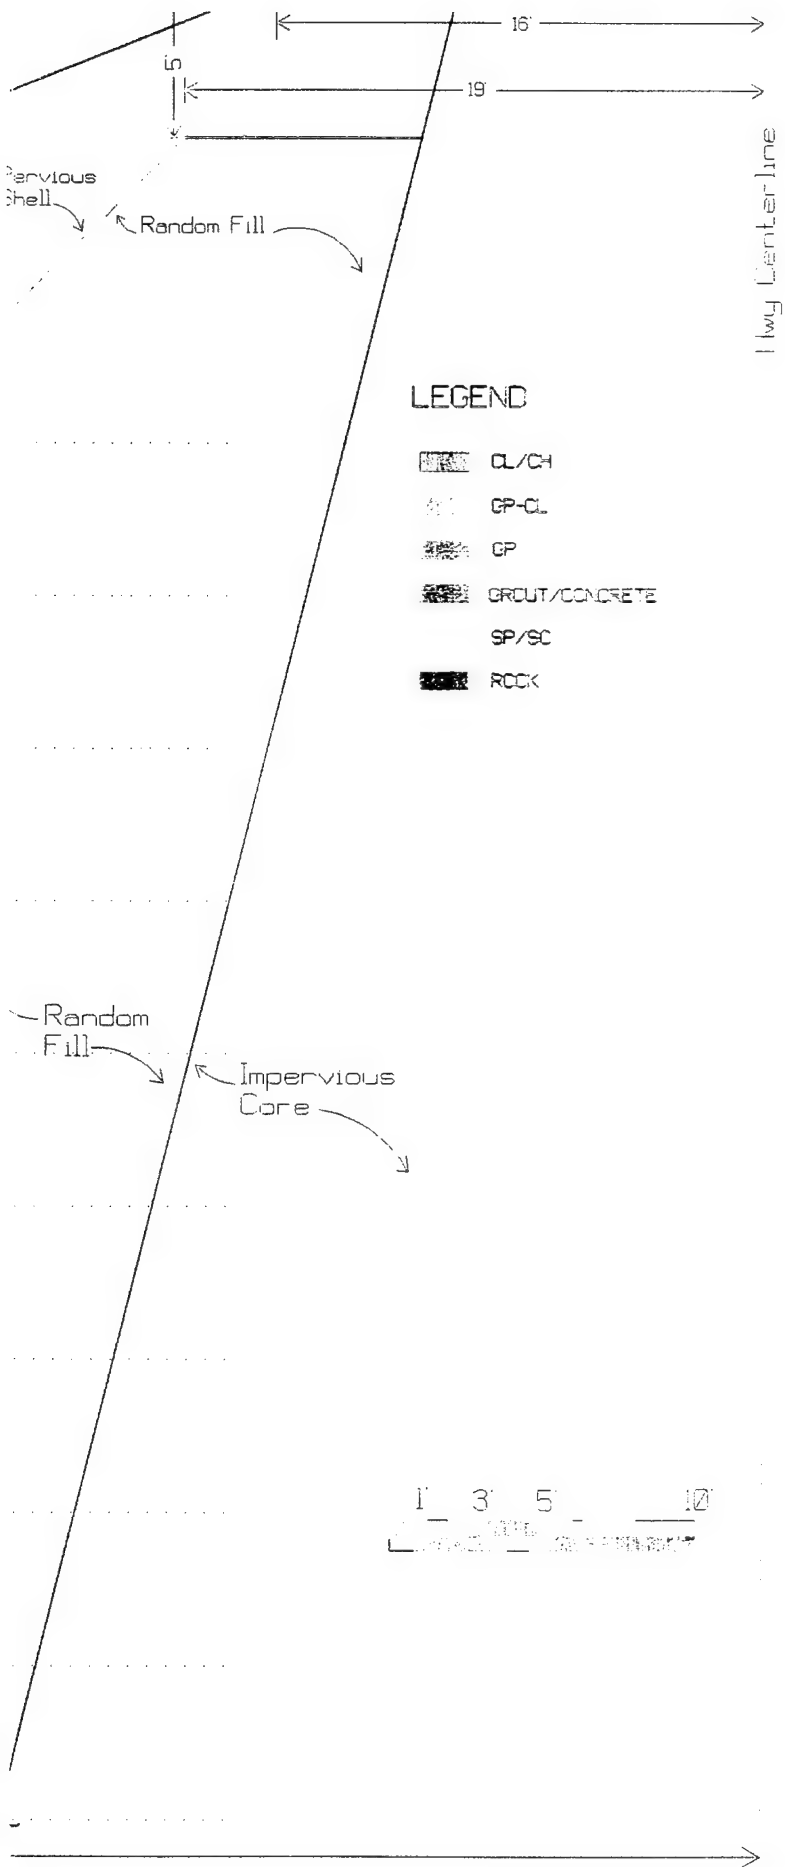
FIGURE 1  
CROSS-SECTION  
OF AS-BUILT  
GROUT CURTAIN

The random fill zone was initially believed to consist totally of clays making it impermeable. This was found not true for the location selected for the grout curtain (Fig-1). Half of the random fill consisted of very large gravel, 2-4 inches in diameter. All of the (GP) material and most of the sand initially produced large amounts of lake water. This change of material from what was anticipated resulted in the deepening of several grout holes that were originally intended to be completed at the top of the random fill zone (Fig-2). This can be seen

when the originally predicted depths of holes in Figure-2 are compared to the As-Constructed depths in Figure-1. If the holes had not been deepened, water would have flowed under the grout curtain. It is hoped that the material below the Sylamore Sandstone is relatively impermeable or this could still occur.

Drilling and grouting results for each hole are summarized in Table-1 and a cross section of the grout curtain area is provided in Figure-1. Further information, including drill logs and a fact sheet made on each boring drilled can be obtain from the Soils, Geology and Materials Section at Little Rock District Office.

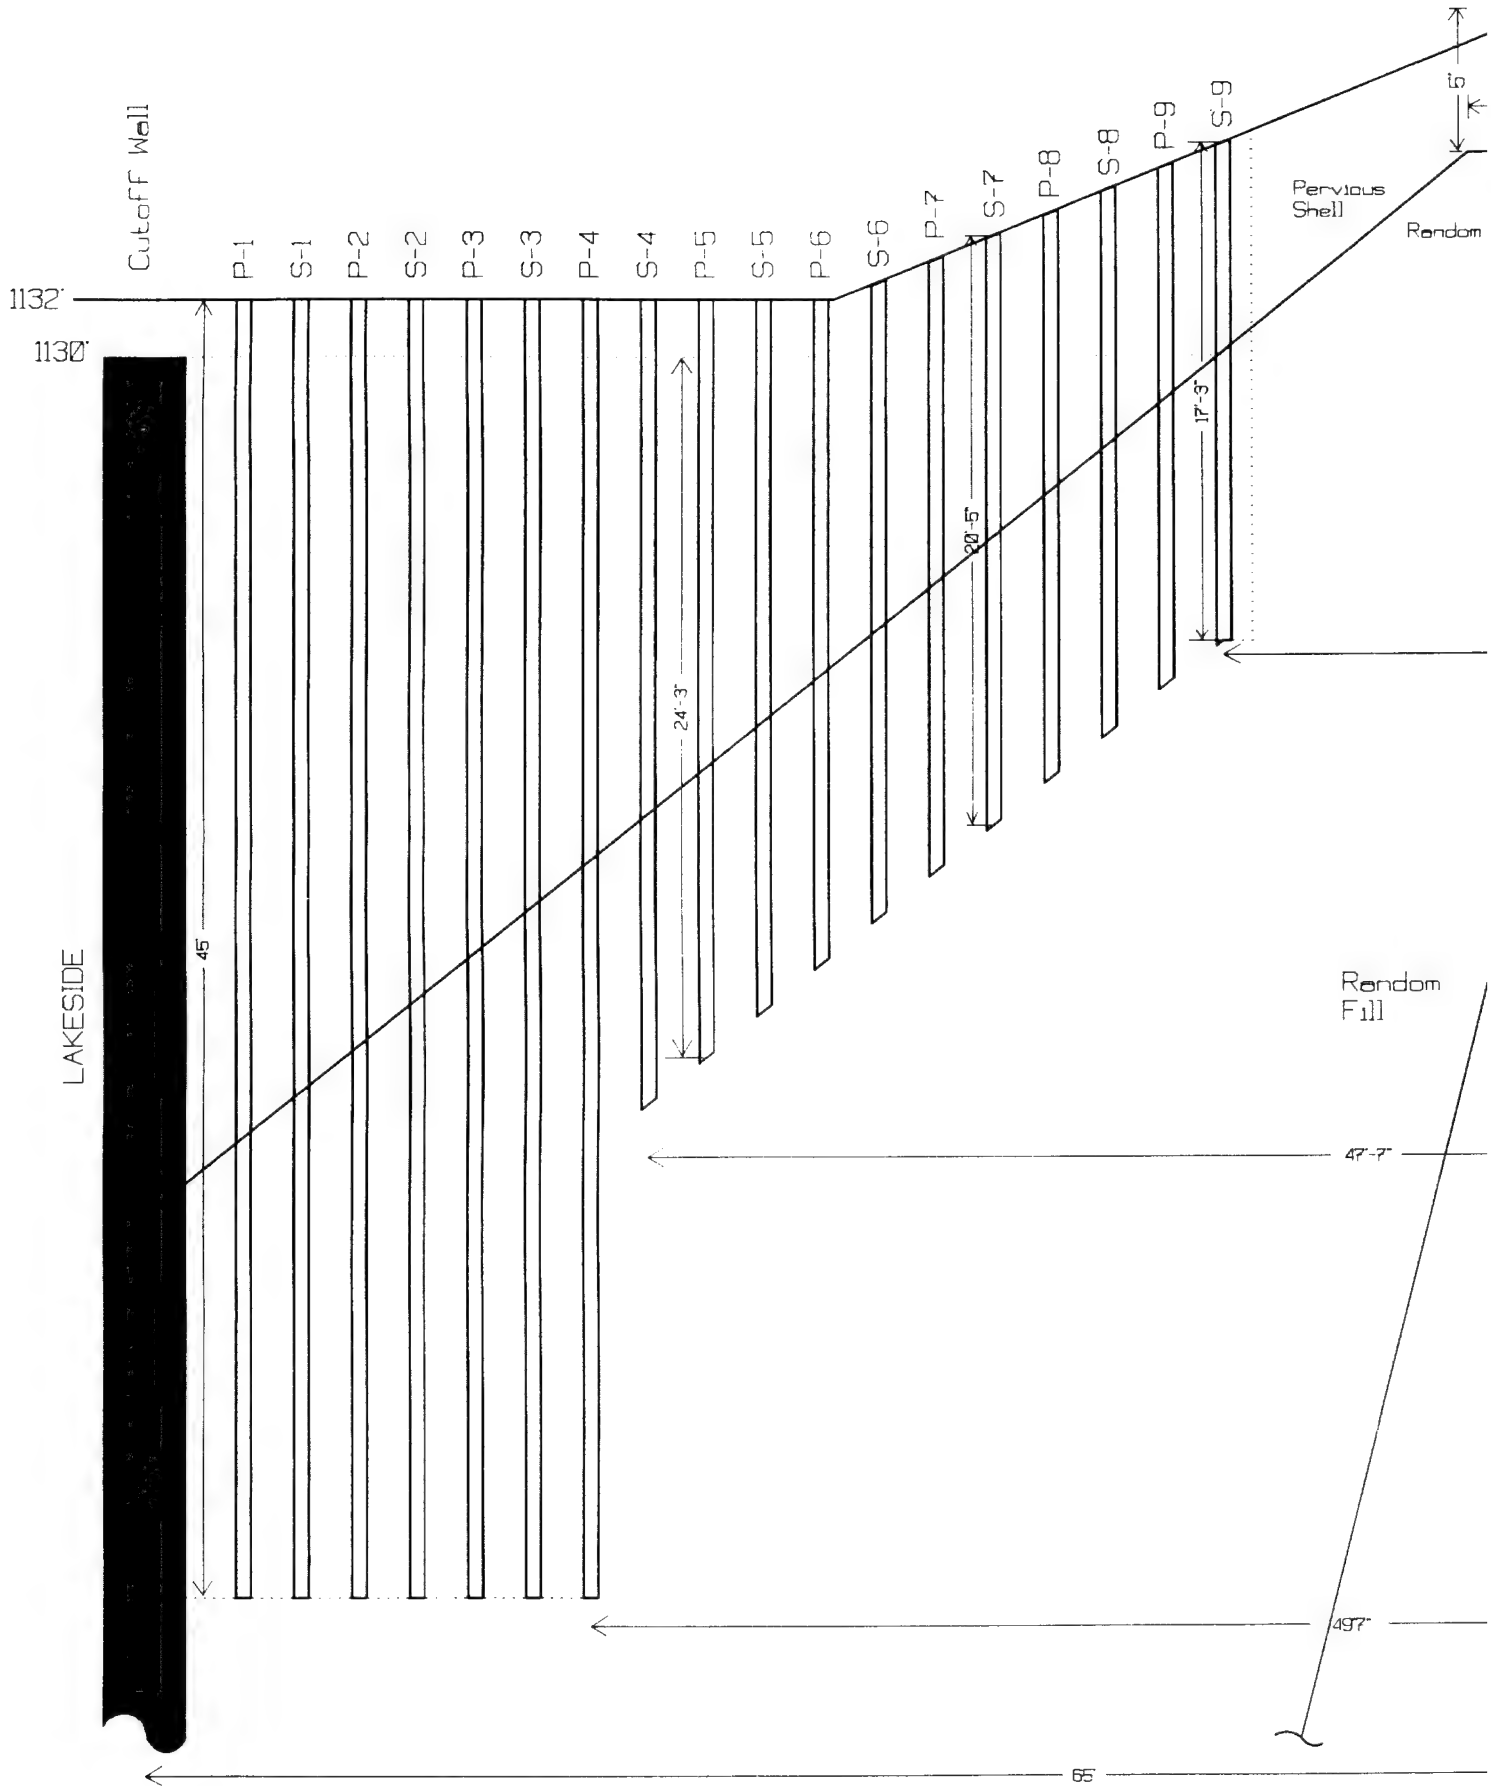
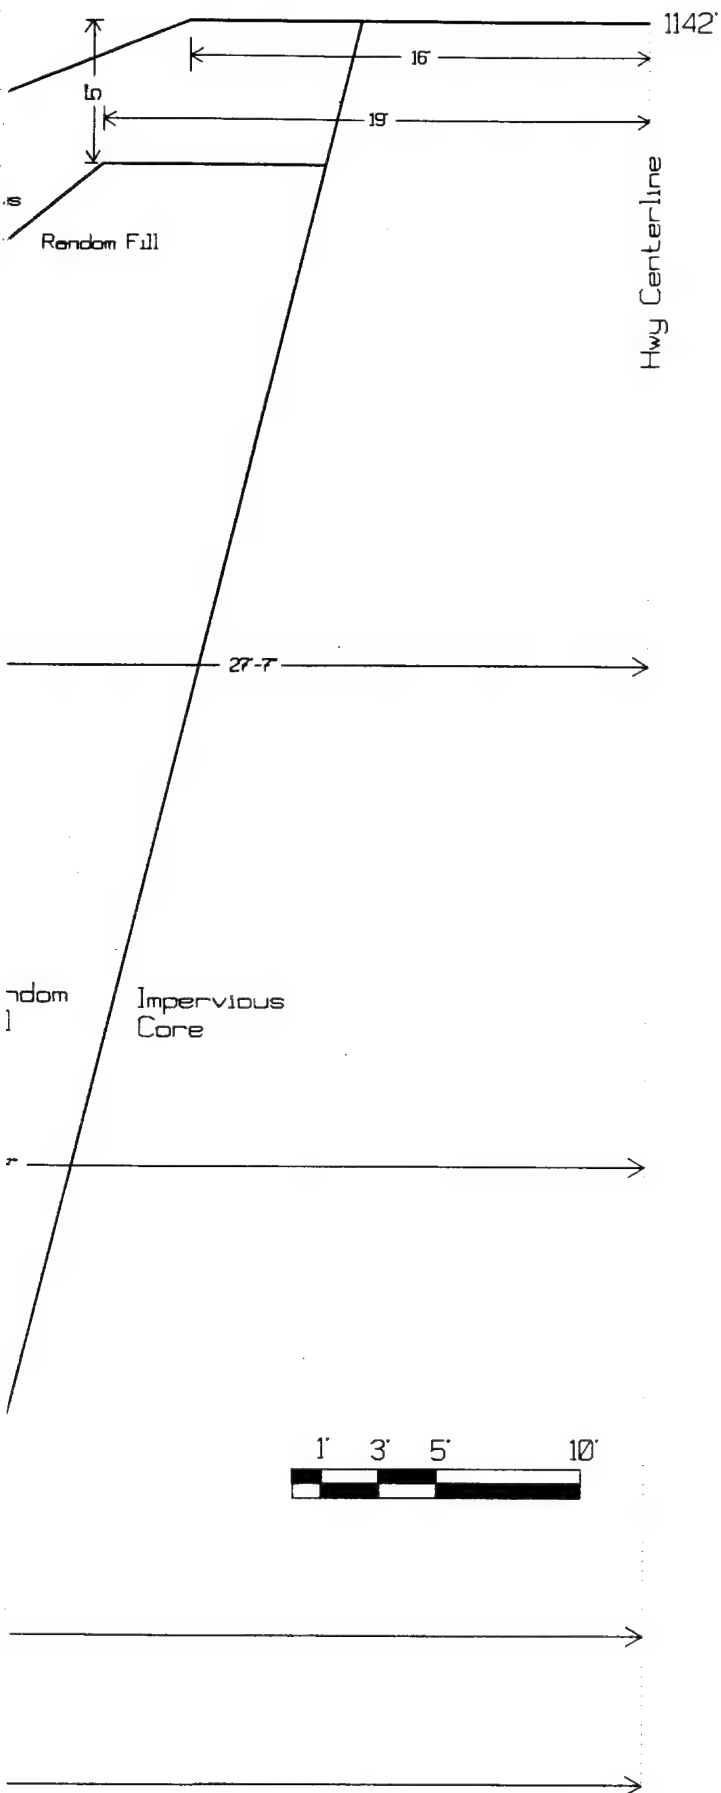
FIGURE 2  
ORIGINAL PLAN  
OF GROUT CURTAIN

1.4 Planning Beaver Wall Extension Grout Curtain. A single line grout curtain extending downstream from the RNJV wall and tying into the impervious portion of the dam was the chosen method of blocking seepage around the south end of the wall (Fig-2). The grout curtain was proposed to be constructed by close spaced drilling (grout holes 2 ft. apart), consisting of primary and secondary holes, with further split spacing if necessary and utilizing gravity as the method of grout placement. The pervious shell was believed to be porous enough that gravity grouting could be used to form the grout curtain. Using gravity alone; however, proved to be inadequate, because of the large amount of fines present in some portions of the pervious shell.

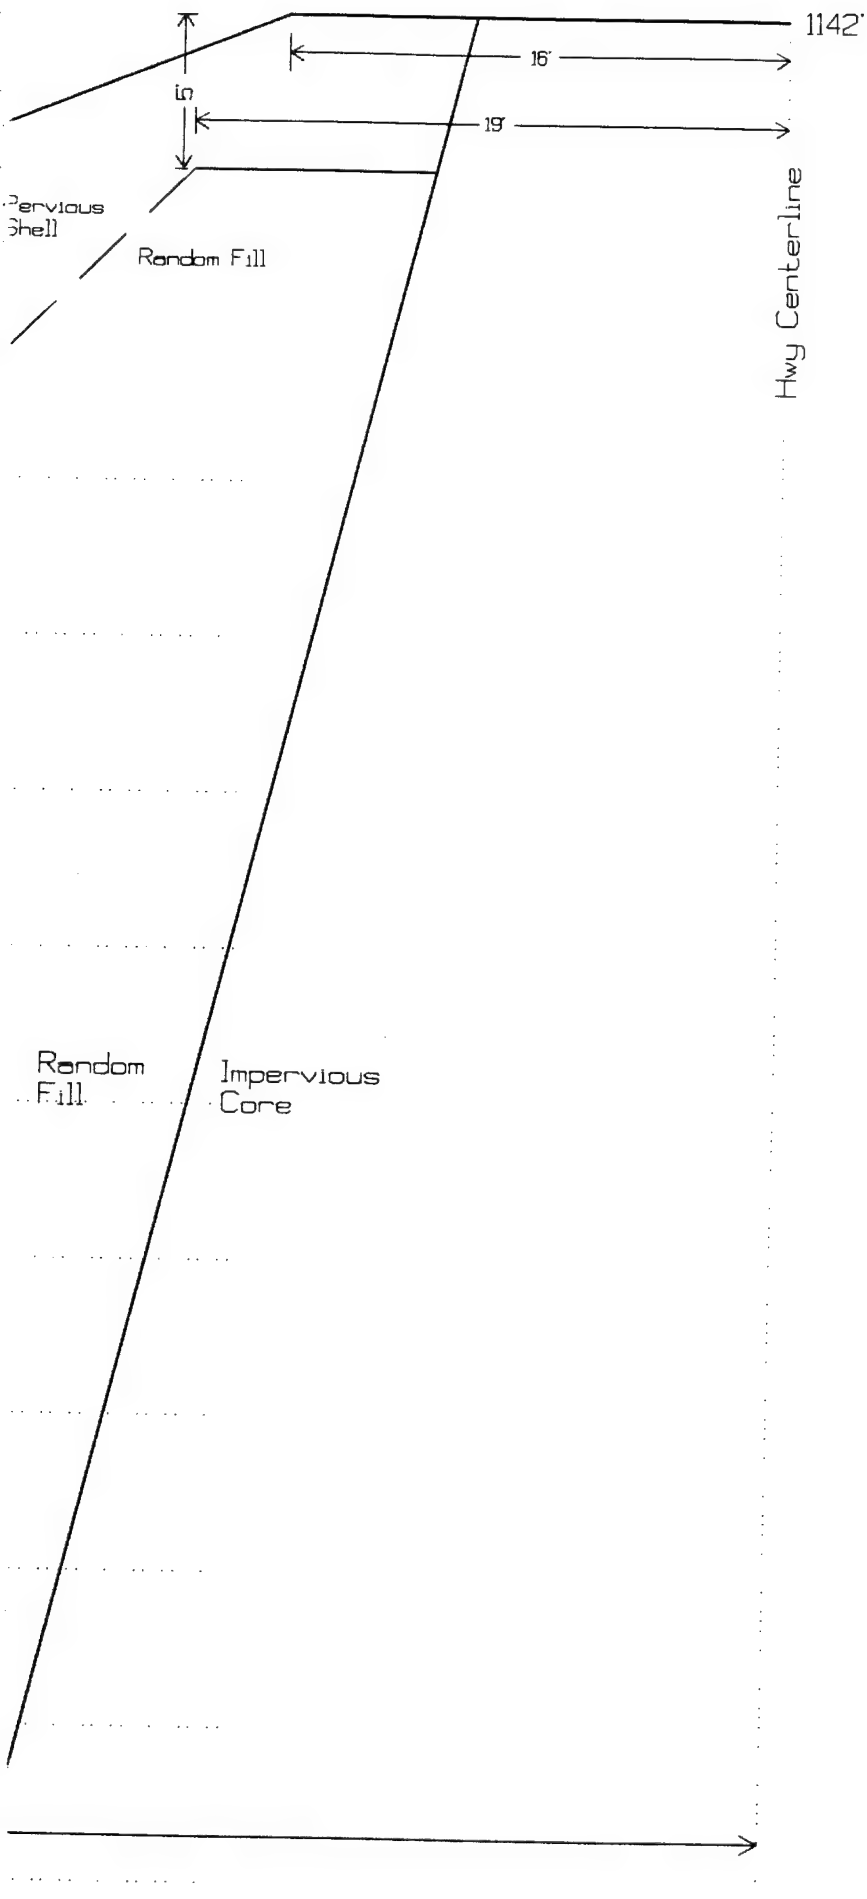
FIGURE 4  
GROUT QUANTITY AND  
PLACEMENT PSI IN  
RANDOM FILL AND  
PERVIOUS SHELL

The last 7 secondary holes also took less grout normally than the primary holes (Table-2, Fig-4) and would have taken significantly less if the grouting pressures had not been increased. The tertiary hole (TS-2) actually took less grout than indicated because it was necessary to wash the hole out

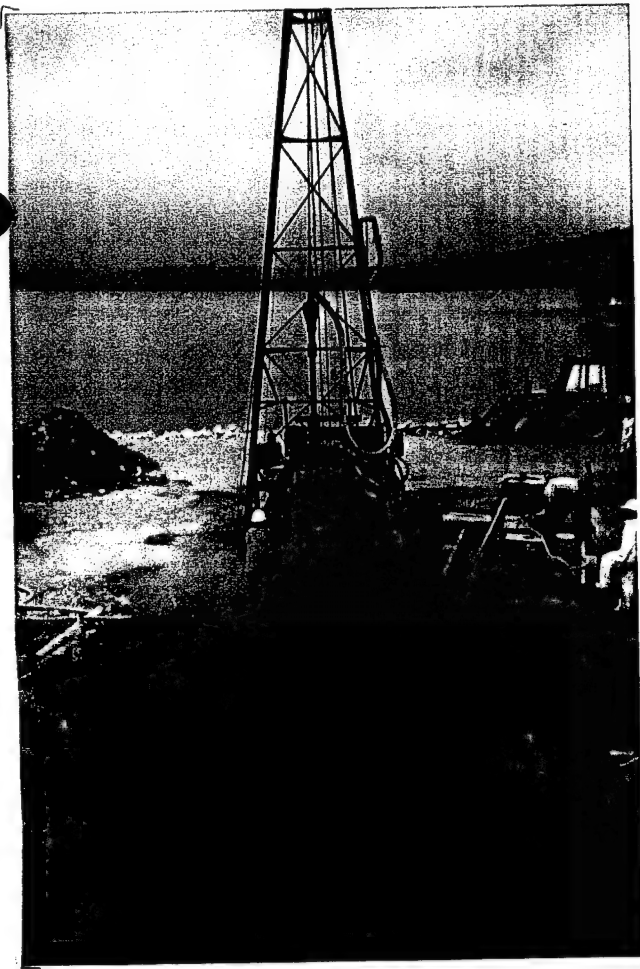
### **PHOTO NO. 1**

Primary Holes like P-5 shown at left produced a lot of water during air drilling.

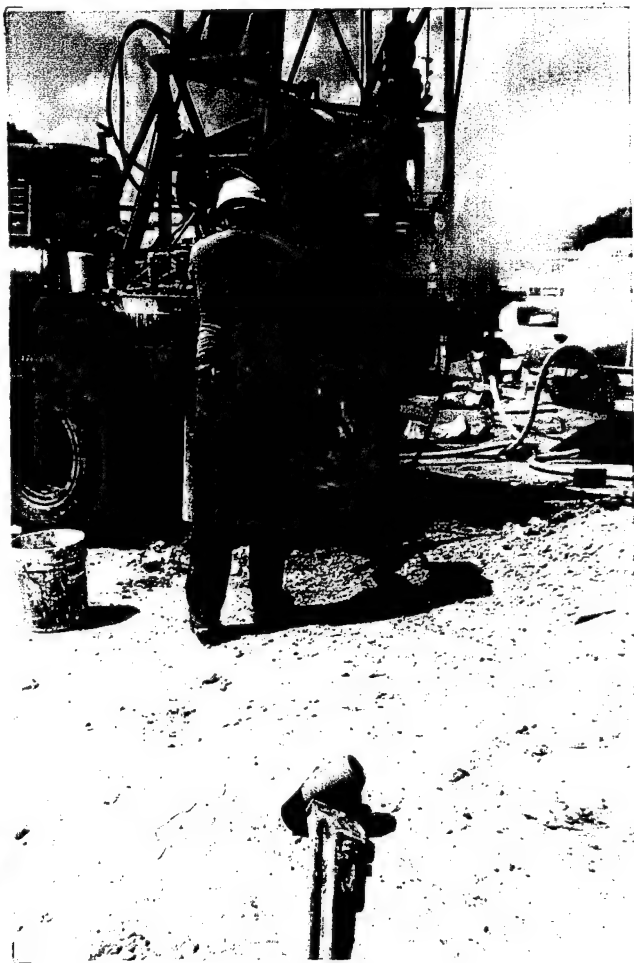
### **PHOTO NO. 2**

Normally, Secoundary Holes like S-4 shown, produced minimal water. (Dust Rises From Hole)
